# Manhole Inspection Summary

Manhole # S51O\_\_052MH

Insp Date: **3/13/09 11:46 AM**

**Location** Address: **2933 odonnell st**

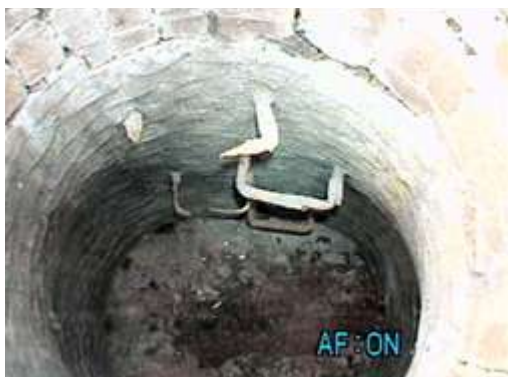
Defect 2

Count: **4** Missing: **2** ☒ **Corroded**

missing/corroded steps

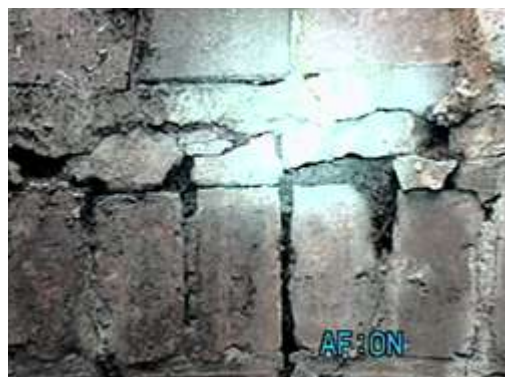
Defect 1

Condition: ☐ Sound ☒ **Cracked** ☐ Root Intrusion ☒ **Loose Brick** ☒ **Deteriorated**

frame adj cracked, loose bricks,  
deteriorated

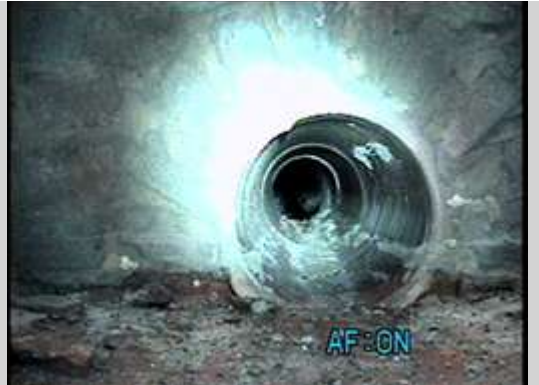
12 O'Clock Outflow

8 in. Circular Gravity Sewer  
Pipe Out @ 12 O'Clock
